**Flood Control Project Maintenance
Levee Inspections**
LMA District Cover Sheet
Spring 2018 Levee Inspection Results

Reclamation District No. 0501 Ryer Island

Spring 2018 Levee Inspection Results

Waterway			Bank	Unit Miles
Unit No. 01 Steamboat Slough			Right	6.71
	Spring (March - May)	Summer (June - August)	(September - November) Fall	Winter (December - February)
Unit Maintenance Rating (Fall Only)				
Date of Inspection	3/13/2018 - 3/13/2018			
DWR Inspector	Keith Millard			
Accompanied By

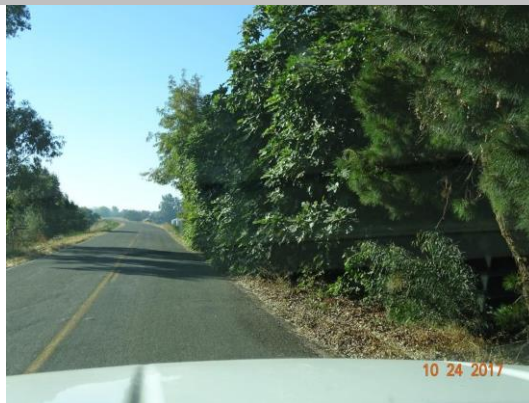
Photo 1 of 1 : SP_2018_RD0501_169_27_20180305_00004.jpg

LM Start	0.28	Rating **	A/W	Issue No.	27
LM End	0.28	Issue Type +	En	Location *	LS
Category	Earthen Levee			GPS Latitude/Longitude	
				Start	End
Item	Vegetation			38.250809 °	38.250809 °
				-121.603119 °	-121.603119 °
DWR ID	DWR_RD0501_01_f_2017_27				
Comment Code					
V6 : Landscaping					
Inspector Comment					
Trim fig trees to allow inspection and access to landside slope and toe.

Trim fig trees to allow inspection and access to landside slope and toe.

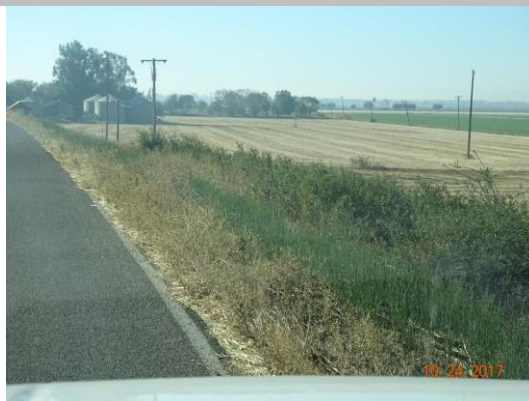
Photo 1 of 1 : SP_2018_RD0501_169_28_20180305_00005.jpg

LM Start	0.31	Rating **	A/W	Issue No.	28
LM End	0.31	Issue Type +	Ma	Location *	LS
Category	Earthen Levee			GPS Latitude/Longitude	
				Start	End
Item	Trim / Thin Trees			38.250340 °	38.250340 °
				-121.603133 °	-121.603133 °
DWR ID	DWR_RD0501_01_f_2017_28				
Comment Code					
T2 : Thin trees to allow visibility of the ground and room to flood fight.					
Inspector Comment					
Trim trees at landside toe to allow inspection and access.

Trim trees at landside toe to allow inspection and access.

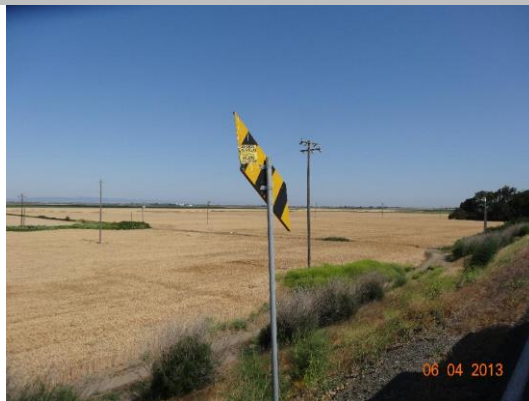
Photo 2 of 3 : UCIP_SP_2018_41409_58930.jpg

Comment Code					
Inspector Comment					
FS_ID:41409					
DS_ID:21032					
EP_NO: N/A					
Repair Type: Non-Urgent					
Crossing Status: Found					
UCIP Comments: Need to contact owner and ask for emergency					
contact information and permit number. 8/21/13 Contacted Gas					
Control Division under the emergency contact No. 1-877-723-3344.					
Message has been forward to Brian Habersack at 916-859-4700, email:					
bhabsack@gasbiz.com.					
FIELD_STRUCT_DESC: 6-inch steel natural gas pipeline under the					
levee, 60 feet below the crown. Gas line marker on each shoulder.					
(Plans to install a 6-inch steel natural gas pipeline across and bored					
under the channel and each levee authorized under Permit No. 17033,					
1999 - Delta Gas Gathering, Inc., and A. A. Production Services, Inc.).					
[Additional Reference(s): DWR Levee Log, 2005].					
FS Date: 6/4/2013

Overview of landside at crossing. Marker on shoulder.

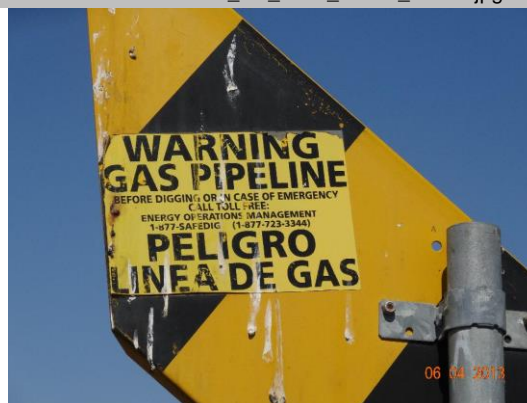
Photo 3 of 3 : UCIP_SP_2018_41409_58932.jpg

Comment Code						
Inspector Comment						
FS_ID:41409 DS_ID:21032 EP_NO: N/A Repair Type: Non-Urgent Crossing Status: Found UCIP Comments: Need to contact owner and ask for emergency contact information and permit number. 8/21/13 Contacted Gas Control Division under the emergency contact No. 1-877-723-3344. Message has been forward to Brian Habersack at 916-859-4700, email: bhabersack@gasbiz.com. FIELD_STRUCT_DESC: 6-inch steel natural gas pipeline under the levee, 60 feet below the crown. Gas line marker on each shoulder. (Plans to install a 6-inch steel natural gas pipeline across and bored under the channel and each levee authorized under Permit No. 17033, 1999 - Delta Gas Gathering, Inc., and A. A. Production Services, Inc.). [Additional Reference(s): DWR Levee Log, 2005]. FS Date: 6/4/2013

Gas line contact information on the sign.

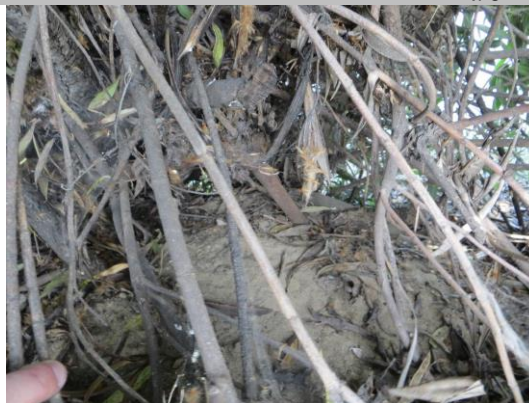
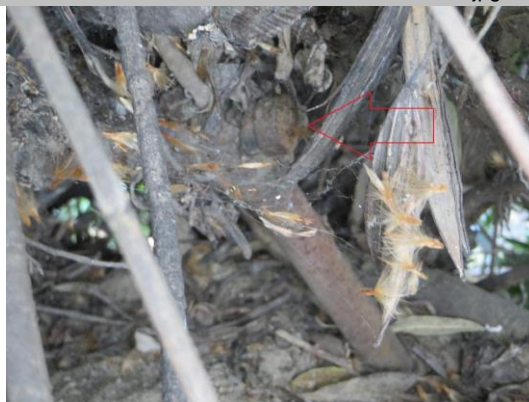
Photo 1 of 3 : UCIP_SP_2018_44643_73842.jpg

Comment Code						
Inspector Comment						
FS_ID:44643 DS_ID:21089 EP_NO: 2683 Repair Type: Non-Urgent Crossing Status: Indicator Found UCIP Comments: Appears abandoned and if so should be done so properly. FIELD_STRUCT_DESC: *ABANDONED* 2-inch steel water pipe and a 1-inch steel electrical conduit through the levee, both 3 feet below the crown. Portion of pipe visible under the oleanders on the landside (LS) shoulder, may be part of this crossing. No evidence remains on the waterside (WS) slope. (Plans for installation of an electrical conduit and a water pipe through the levee authorized under Permit No. 2683, 1957 - John Gosner). FS Date: 4/21/2015

Pipes visible under oleander on LS shoulder.

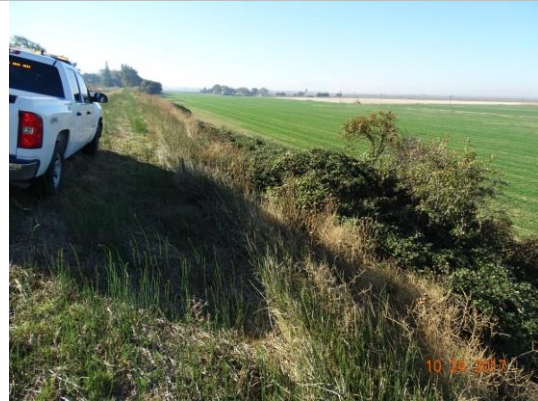
Photo 1 of 1 : SP_2018_RD0501_169_29_20180305_00006.jpg

LM Start	0.76	Rating **	M	Issue No.	29
LM End	1.01	Issue Type +	Ma	Location *	LS
Category	Earthen Levee			GPS Latitude/Longitude	
				Start	End
Item	Vegetation			38.243815 °	38.240257 °
				-121.603077 °	-121.603873 °
DWR ID	DWR_RD0501_01_f_2017_29				
Comment Code					
V2 : Remove the wild growth other than native grasses from the levee slopes.					
Inspector Comment					
Landside slope is covered in blackberry vines. Should be removed to allow inspection and access.

Landside slope is covered in blackberry vines. Should be removed to allow inspection and access.

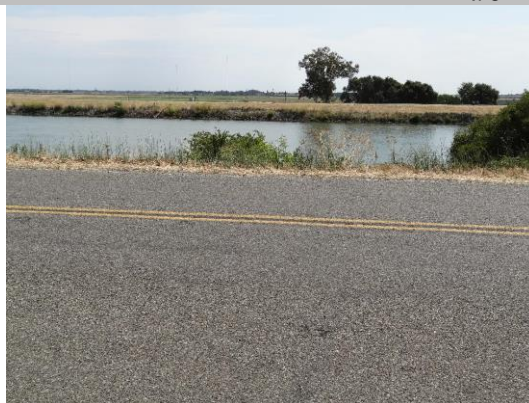
Photo 2 of 3 : UCIP_SP_2018_50020_75647.jpg

Comment Code						
Inspector Comment						
FS_ID:50020 DS_ID:21034 EP_NO: N/A Repair Type: Non-Urgent Crossing Status: Found UCIP Comments: 8/22/2016 Crossing has been downgraded from Urgent to Non-Urgent -- no evidence of damage to levee is present. Dense vegetation limits the inspector's visibility to identify signs of pipe failure (leaks) through the slope. Recommend removing vegetation along pipe alignment to conduct proper inspection of structure and appurtenances. Also will need to coordinate with owner to determine if permit was obtained for the modifications made to crossing (PVC pipe sleeved through existing pipe). (DWR UCIP - omagana)4/21/2015 Unauthorized PVC pipe. Annular space not grouted. 14-inch pipe open on both ends. (DWR UCIP - omagana) FIELD_STRUCT_DESC: 14-inch steel irrigation siphon pipe through the levee, 3.2 feet below the crown. 10-inch polyvinyl chloride (PVC) pipe sleeved through the 14-inch pipe. Siphon breaker on the landside (LS) shoulder. [Additional Reference(s): DWR Levee Log, 2005. USACE Sacramento O&M Manual 105, April 1959, (HLM 1.0)]. FS Date: 8/22/2016

View of levee crown looking at waterside.

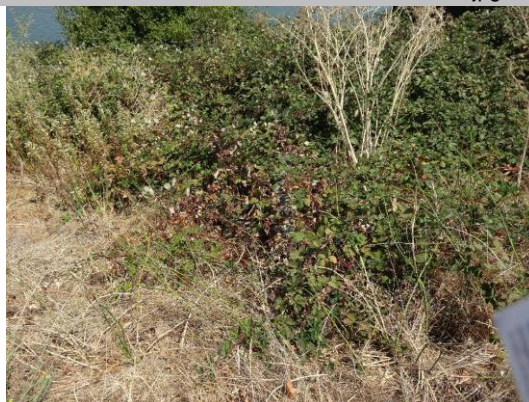
Photo 3 of 3 : UCIP_SP_2018_50020_75645.jpg

Dense vegetation covers WS--pipe slightly visible through vegetation.

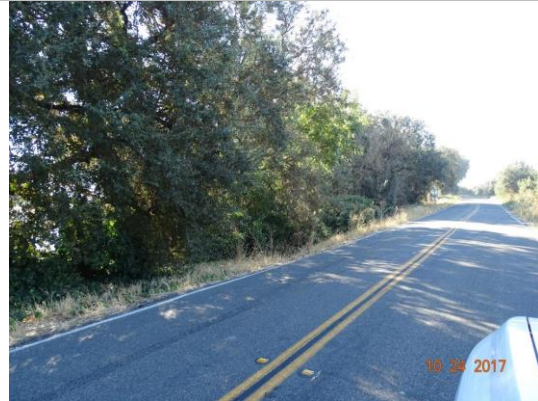
Photo 1 of 1 : SP_2018_RD0501_169_31_20180305_00008.jpg

LM Start	1.01	Rating **	M	Issue No.	31
LM End	1.11	Issue Type +	Ma	Location *	WS
Category	Earthen Levee			GPS Latitude/Longitude	
				Start	End
Item	Vegetation			38.240222 °	38.238918 °
				-121.603887 °	-121.604338 °
DWR ID	DWR_RD0501_01_f _ 2017_31				
Comment Code					
V2 : Remove the wild growth other than native grasses from the levee slopes.					
Inspector Comment					
Waterside vegetation should be thinned/removed to 20' from crown to allow inspection and access.

Waterside vegetation should be thinned/removed to 20' from crown to allow inspection and access.

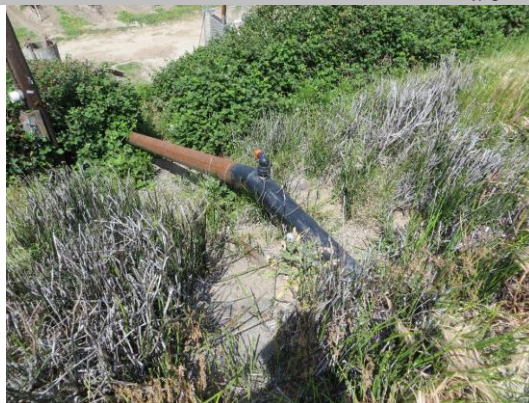
Photo 2 of 3 : UCIP_SP_2018_47516_73856.jpg

FS_ID:47516
DS_ID:21086
EP_NO: 13233
Repair Type: Non-Urgent
Crossing Status: Found
UCIP Comments: Annular space between pipes not grouted. FPIIB Inspector Herman Phillips will contact owner regarding lack of permit for sand filters. Steel plate partially covers openings between pipes.
FIELD_STRUCT_DESC: 14-inch coated steel irrigation discharge pipe through the levee, 2.5 feet below the crown. 8-inch steel pipe sleeved through the 14-inch pipe. Cutoff wall around the pipe at the center of the levee. Pump and check valve in a pump house on the waterside (WS) slope. Service pole on the landside (LS) slope. A 1.5-inch and a 2.5-inch electrical conduits at the same location. Siphon breaker on each shoulder. (Plans to replace a 12-inch irrigation pipe through the levee authorized under Permit No. 11813, 1976 - Harry H. Rasmussen. Plans to replace irrigation pipe with a 14-inch pipe through the levee authorized under Permit No. 13233, 1981 - Harry H. Rasmussen. Plans to install an 8-inch steel pipe through an existing 14-inch pipe through the levee authorized under Permit No. 11813-1, 2013 - Matt Davis).

8-inch steel pipe with vent/siphon breaker on LS shoulder. Pipe sleeved through 14-inch steel pipe. Electrical conduit visible next to pipe.

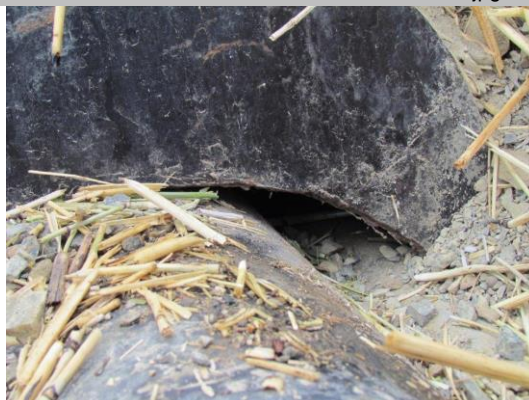
Photo 3 of 3 : UCIP_SP_2018_47516_75034.jpg

LS: (photo from FPIIB Inspector H. Phillips) Annular space not grouted.

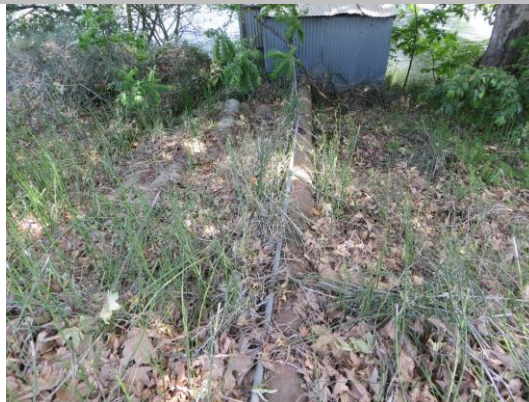
Photo 2 of 3 : UCIP_SP_2018_44683_73881.jpg

LM Start	2.34	Rating **	M	Issue No.	986	
LM End	2.34	Issue Type +	En	Location *		
Category	Supplemental			GPS Latitude/Longitude		
				Start		End
Item	DWR UCIP Field Study			38.221277 °	38.221277 °	
				-121.603505 °	-121.603505 °	
DWR ID						
Comment Code						
Inspector Comment						
FS_ID:44683 DS_ID:21021 EP_NO: N/A Repair Type: Non-Urgent Crossing Status: Found UCIP Comments: Appears abandoned and if so should be done so properly. Discarded pipe on WS slope should be removed. FIELD_STRUCT_DESC: 10-inch steel irrigation discharge pipe through the levee, 2.5 feet below the crown. Pump and gate valve in a pump house on the waterside (WS) slope. 4-foot by 4-foot concrete distribution box, power pole, and meter at the landside (LS) toe. [Additional Reference(s): DWR Levee Log, 2005. USACE Sacramento O&M Manual 105, April 1959, (HLM 2.5)]. FS Date: 4/21/2015

Pipe and pumphouse on WS slope.

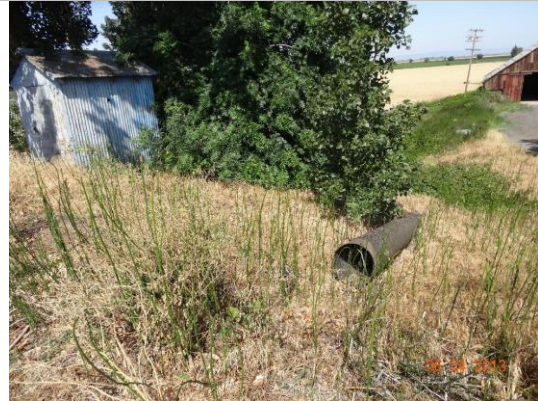
Photo 2 of 3 : UCIP_SP_2018_32526_58935.jpg

FS_ID:32526
DS_ID:21022
EP_NO: 2742
Repair Type: Non-Urgent
Crossing Status: Found
UCIP Comments: Dense vegetation limits the inspector's visibility to identify signs of pipe failure (leaks) through the levee slopes. Recommend removing vegetation along pipe alignment to conduct proper inspection of structure and appurtenances. Additional notes: pump was running during inspection, 16-inch pipe debris section located on landward side, view of standpipe and support structure on waterward side does not match structure description--need to determine if crossing has been altered.
FIELD_STRUCT_DESC: 16-inch coated steel drainage discharge pipe through the levee, 3.6 feet below the crown. Cutoff walls around the pipe at the center of the levee. Siphon breaker on the apex of the pipe on the landside (LS) shoulder. Pump house on the LS shoulder. Pipe discharges into a 48-inch pipe with a screw gate on the LS. Rock revetment placed on the waterside (WS) slope. Revegetation in progress on the WS. (Plans to install a 16-inch siphon through the levee authorized under Permit No. 2742, 1958 - Reclamation District No. 501 [RD0501]. Plans to replace a portion of an existing 16-inch discharge pipe through the levee authorized under Permit No. 15380, 1999 - RD0501). [Additional Reference(s): DWR Levee Log, 2005].

Pump house on landward slope. An abandoned pipe section on landward slope.

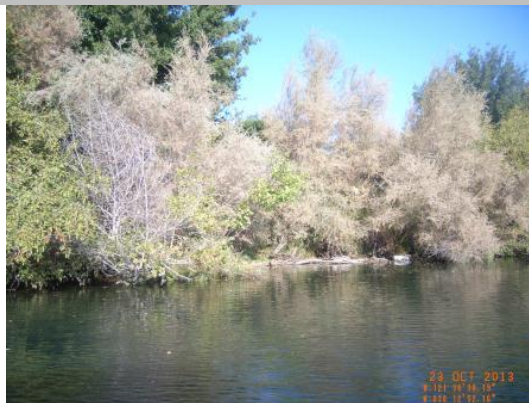
Photo 1 of 1 : SP_2018_RD0501_169_3_20180305_00003.jpg

LM Start	2.85	Rating **	M	Issue No.	3
LM End	2.91	Issue Type +	Ma	Location *	WS
Category	Supplemental			GPS Latitude/Longitude	
				Start	End
Item	2015 USACE Erosion Survey, DRAFT			38.214838 °	38.214075 °
				-121.608129 °	-121.608750 °
DWR ID	DWR_RD0501_01_f_2016_3				
Comment Code					
Inspector Comment					
2009 - Rock is starting to unravel, probably from a tree pop-out, hard toe. 2015: No observed changes. [2015 Site ID: STM_18-9_R]

USACE 2013 Photo #1

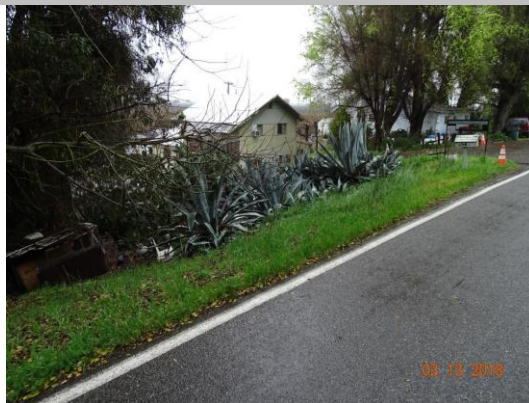
Photo 1 of 1 : SP_2018_RD0501_169_15_20180313_00064.jpg

LM Start	3.19	Rating **	M	Issue No.	15
LM End	3.22	Issue Type +	En	Location *	LS
Category	Earthen Levee			GPS Latitude/Longitude	
				Start	End
Item	Vegetation			38.210429 °	38.209974 °
				-121.610503 °	-121.610703 °
DWR ID	DWR_RD0501_01_s_2012_15				
Comment Code					
V6 : Landscaping					
Inspector Comment					
Large cactus and other landscaping should be thined or removed to allow inspection and access to landside slope and toe.

Cactus should be removed to allow inspection and access to levee slope.

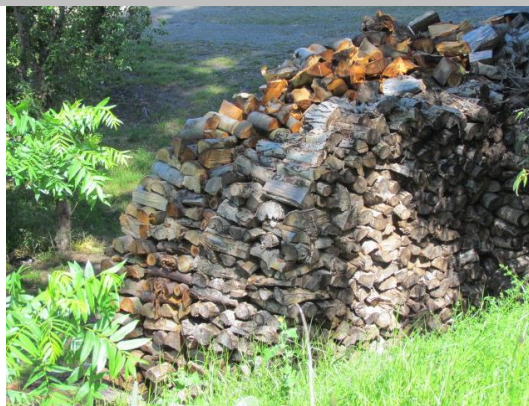
Photo 1 of 2 : SP_2018_RD0501_169_63_20180305_00013.jpg

LM Start	3.24	Rating **	U	Issue No.	63
LM End	3.24	Issue Type +	En	Location *	LS
Category	Earthen Levee			GPS Latitude/Longitude	
				Start	End
Item	Encroachments			38.209811 °	38.209713 °
				-121.610813 °	-121.610882 °
DWR ID	DWR_RD0501_01_f_2012_63				
Comment Code					
MA : Material					
Inspector Comment					
There is a large stock pile of fire wood, metal scrap, and other unwanted materials placed withn the 10-foot easement landside that ned to be removed.

RD 501 Unit 1 levee mile 3.24 landside toe.

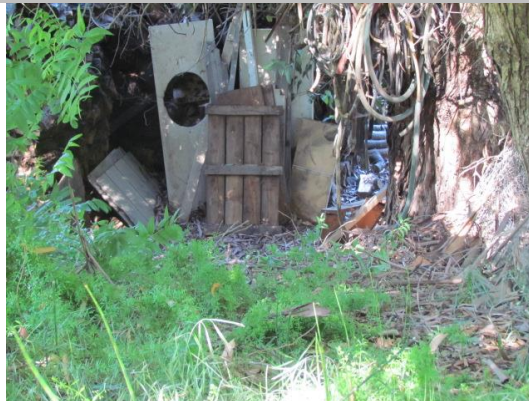
Photo 2 of 2 : SP_2018_RD0501_169_63_20180305_00014.jpg

RD 501 Levee mile 3.24 landside toe.

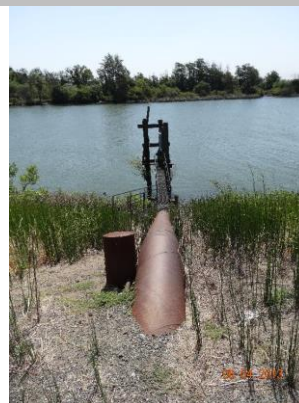
Photo 2 of 3 : UCIP_SP_2018_32529_58951.jpg

View of waterward side--siphon breaker, walkway, platform, pump, and control panel.

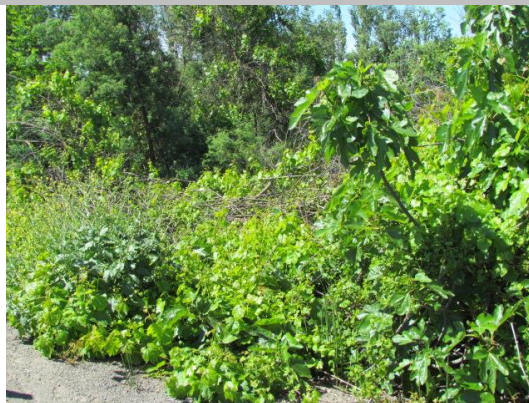
Photo 2 of 2 : SP_2018_RD0501_169_974_20180305_00016.jpg

LM Start	3.73	Rating **	A/W	Issue No.	974 (cont)	
LM End	4.12	Issue Type +	Ma	Location *	WS	
Category	Earthen Levee			GPS Latitude/Longitude		
				Start		End
Item	Vegetation			38.202997 °		38.197778 °
				-121.613450 °		-121.616080 °
DWR ID	DWR_RD0501_01_s_2012_974					
Comment Code						
V2 : Remove the wild growth other than native grasses from the levee slopes.						
Inspector Comment						
Vegetation has been cleared to 20 feet from crown.

RD 501 Levee mile 3.73-4.12 wild tree growth and vegetation blocking view of the levee slope.

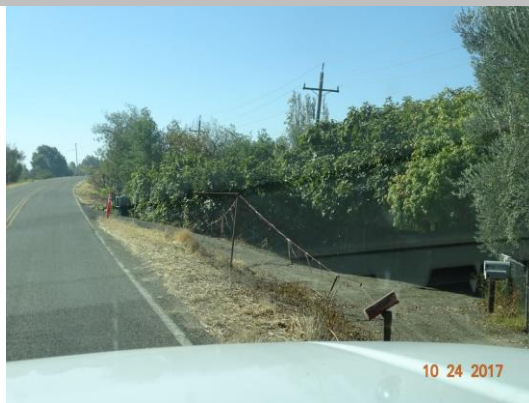
Photo 1 of 1 : SP_2018_RD0501_169_30_20180305_00007.jpg

LM Start	3.74	Rating **	M	Issue No.	30
LM End	3.74	Issue Type +	En	Location *	LS
Category	Earthen Levee			GPS Latitude/Longitude	
				Start	End
Item	Vegetation			38.202863 °	38.202863 °
				-121.613508 °	-121.613508 °
DWR ID	DWR_RD0501_01_f_2017_30				
Comment Code					
V6 : Landscaping					
Inspector Comment					
Landscaping should be thinned to allow inspection and access to slope and toe. Downed deadwood should also be removed from slope.

Landscaping should be thinned to allow inspection and access to slope and toe. Downed deadwood should also be removed from slope.

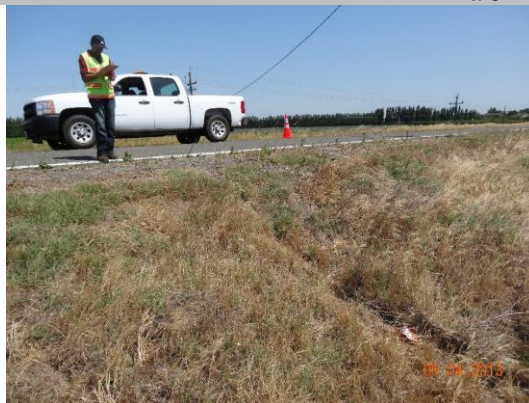
Photo 1 of 3 : UCIP_SP_2018_19644_33328.jpg

View of waterward side.

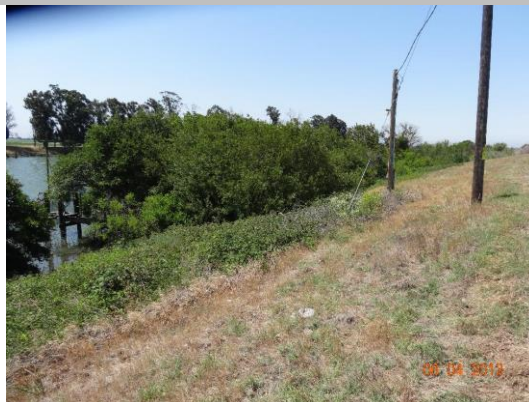
Photo 2 of 3 : UCIP_SP_2018_19644_33331.jpg

Overview of waterward side--pump station, platform, & power pole.

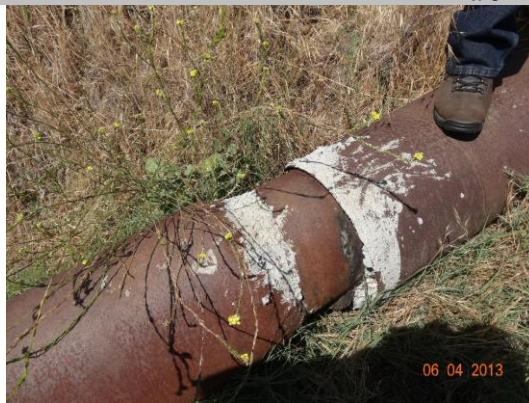
Photo 3 of 3 : UCIP_SP_2018_19644_33326.jpg

Comment Code						
Inspector Comment						
FS_ID:19644 DS_ID:21016 EP_NO: N/A Repair Type: Non-Urgent Crossing Status: Found UCIP Comments: Pipe section was altered/modified through levee crown. 12-inch pipe sleeved through existing pipe. Dense vegetation limits the inspector's visibility to identify signs of pipe failure (leaks) through the slope. Additional Notes: electrical conduit is disconnected on landside. Recommend removing vegetation along pipe alignment to conduct proper inspection of structure and appurtenances. Also need to contact owner to obtain maintenance records for crossing--need permit authorizing modifications. FIELD_STRUCT_DESC: 14-inch irrigation discharge pipe of an unknown material through the levee, 3.2 feet below the crown. 12-inch pipe sleeved through the existing 14-inch pipe with annular space grouted. 1.5-inch electrical conduit runs parallel along the 14-inch pipe. Pump on a pile structure in the channel. Walkway to the pump. [Additional Reference(s): DWR Levee Log, 2005. USACE Sacramento O&M Manual 105, April 1959, (HLM 4.6), 14-inch pipe listed]. FS Date: 6/4/2013

12-inch pipe sleeved through existing 14-inch pipe, and annular space grouted--waterward side.

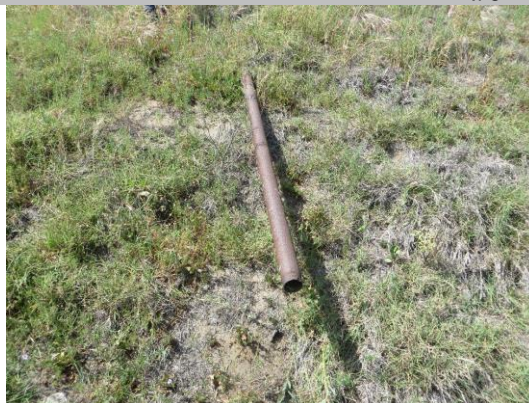
Photo 1 of 3 : UCIP_SP_2018_50024_73901.jpg

2.5-inch conduit visible on WS slope.

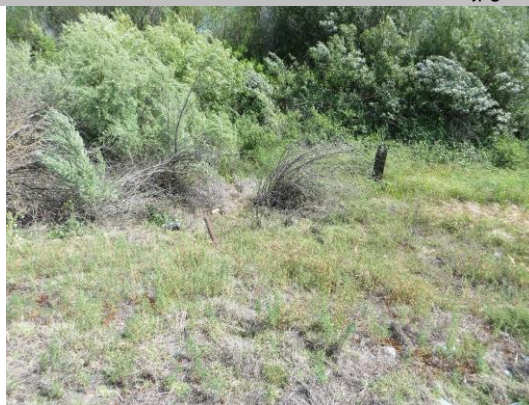
Photo 2 of 3 : UCIP_SP_2018_50024_73900.jpg

FS_ID:50024
DS_ID:21017
EP_NO: N/A
Repair Type: Non-Urgent
Crossing Status: Found
UCIP Comments: 8/22/2016 Unable to locate conduit due to dense vegetation. Electrical conduit crossing has been downgraded from Urgent to Non-Urgent no damage to levee was observed. Dense vegetation was observed on both WS and LS. Recommend removing vegetation along pipe alignment to conduct proper inspection of structure and appurtenances. If crossing is abandoned owner will need to coordinate with CVFPB to remove crossing. (DWR UCIP - omagana)4/21/2016 Pipe abandoned and open on WS slope. Should be removed or abandoned properly. (DWR UCIP - omagana)
FIELD_STRUCT_DESC: *ABANDONED* 2.5-inch steel electrical conduit through the levee, 4 feet below the crown. No Location marker was found on the waterside (WS) slope. [Additional Reference(s): DWR Levee Log, 2005].
FS Date: 8/22/2016

2.5-inch conduit visible on WS slope.

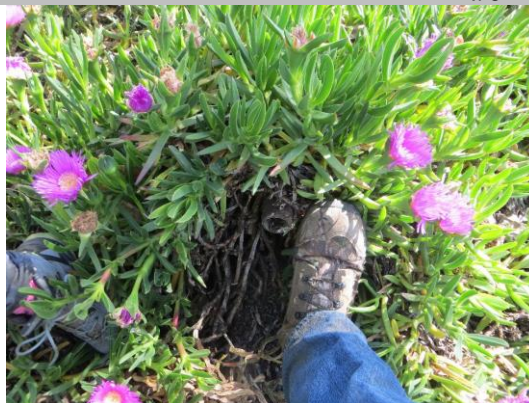
Photo 1 of 3 : UCIP_SP_2018_44720_73904.jpg

Pipe visible on LS slope. Succulants mound up over pipe.

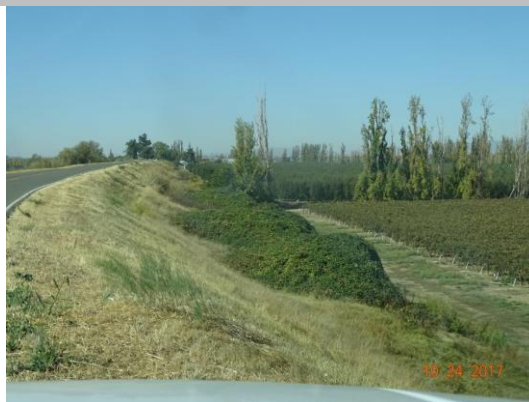
Photo 1 of 1 : SP_2018_RD0501_169_35_20180305_00009.jpg

LM Start	4.64	Rating **	M	Issue No.	35
LM End	4.64	Issue Type +	Ma	Location *	LS
Category	Earthen Levee			GPS Latitude/Longitude	
				Start	End
Item	Vegetation			38.194463 °	38.194463 °
				-121.624310 °	-121.624310 °
DWR ID	DWR_RD0501_01_f_2017_35				
Comment Code					
V2 : Remove the wild growth other than native grasses from the levee slopes.					
Inspector Comment					
Very large mounds of blackberry vines prohibit inspection and access. Should be removed.

Very large mounds of blackberry vines prohibit inspection and access. Should be removed.

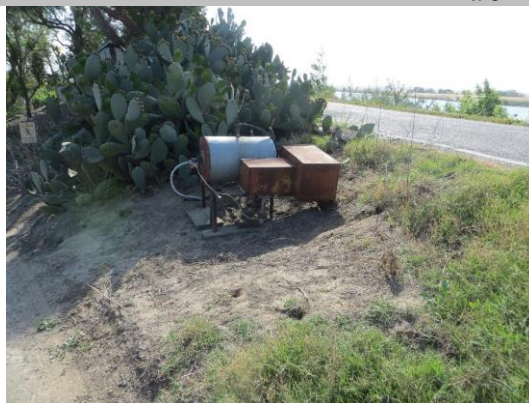
Photo 1 of 3 : UCIP_SP_2018_44726_73922.jpg

Comment Code					
Inspector Comment					
FS_ID:44726 DS_ID:21018 EP_NO: N/A Repair Type: Non-Urgent Crossing Status: Found UCIP Comments: Crossing appears abandoned as there are no connections at siphon pump on LS shoulder. If it is abandoned it should be done so properly. FIELD_STRUCT_DESC: 14-inch steel irrigation siphon pipe sleeved through a 16-inch steel pipe through the levee, 3 feet below the crown. Annular space grouted. Siphon pump/breaker on the landside (LS) shoulder. Steel standpipe with a slide gate at the LS toe. [Additional Reference(s): DWR Levee Log, 2005. USACE Sacramento O&M Manual 105, April 1959, (HLM 5.4), 16-inch pipe listed]. FS Date: 4/23/2015

Siphon pump on LS shoulder. No connection at this time.

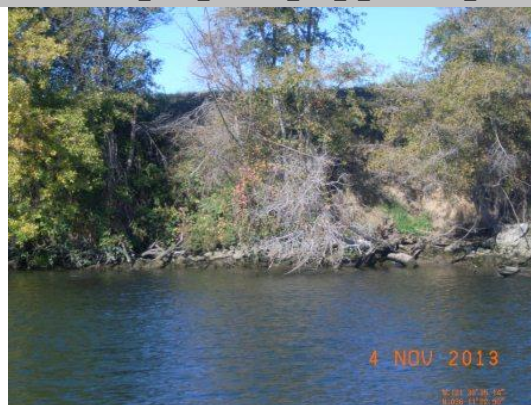
Photo 1 of 1 : SP_2018_RD0501_169_1_20180305_00001.jpg

LM Start	5.77	Rating **	M	Issue No.	1
LM End	5.84	Issue Type +	Ma	Location *	WS
Category	Supplemental			GPS Latitude/Longitude	
				Start	End
Item	2015 USACE Erosion Survey, DRAFT			38.190001 °	38.189311 °
				-121.643160 °	-121.643917 °
DWR ID	DWR_RD0501_01_f_2017_1				
Comment Code					
Inspector Comment					
2008 - Overstepped levee section with multiple small pockets of erosion 10 - 20 ft wide. 2013 - Site has fresh erosion and taller vertical sections. 2015: No observed changes. [2015 Site ID: STM_15-7_R]

USACE 2013 Photo #1

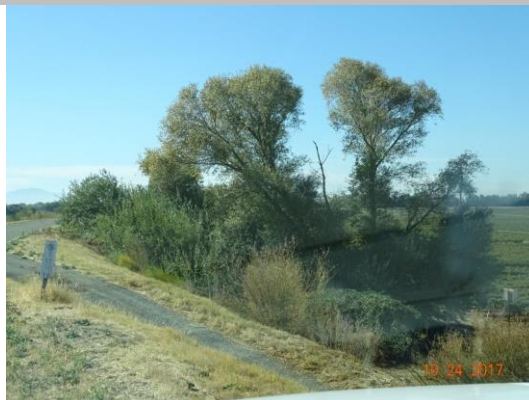
Photo 1 of 1 : SP_2018_RD0501_169_38_20180305_00010.jpg

LM Start	5.89	Rating **	U	Issue No.	38
LM End	5.89	Issue Type +	Ma	Location *	LS
Category	Earthen Levee			GPS Latitude/Longitude	
				Start	End
Item	Trim / Thin Trees			38.188870 °	38.188870 °
				-121.644732 °	-121.644732 °
DWR ID	DWR_RD0501_01_f_2017_38				
Comment Code					
T2 : Thin trees to allow visibility of the ground and room to flood fight.					
Inspector Comment					
Trim/thin/remove trees and undergrowth to allow inspection and access to slope and toe. (LMA reports USDFW objects to trimming/thinning/mowing.)

Trim/thin/remove trees and undergrowth to allow inspection and access to slope and toe.

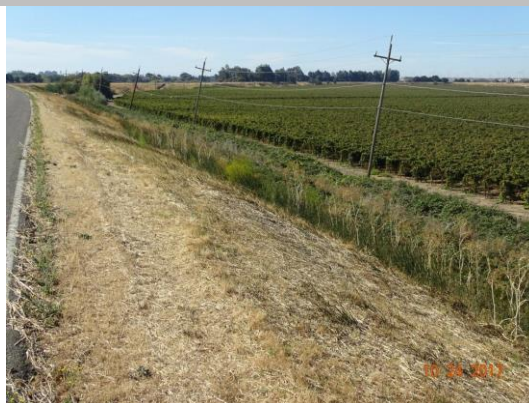
Photo 1 of 1 : SP_2018_RD0501_169_39_20180305_00011.jpg

LM Start	5.94	Rating **	M	Issue No.	39
LM End	6.15	Issue Type +	Ma	Location *	LS
Category	Earthen Levee			GPS Latitude/Longitude	
				Start	End
Item	Vegetation			38.188283 °	38.186090 °
				-121.645398 °	-121.648027 °
DWR ID	DWR_RD0501_01_f_2017_39				
Comment Code					
V2 : Remove the wild growth other than native grasses from the levee slopes.					
Inspector Comment					
Heavy blackberry growth along toe should be removed to allow inspection and access to toe. LMA reports ditch near toe inhibits ability to mow.

Heavy blackberry growth along toe, possibly over fence, should be removed to allow inspection and access to toe.

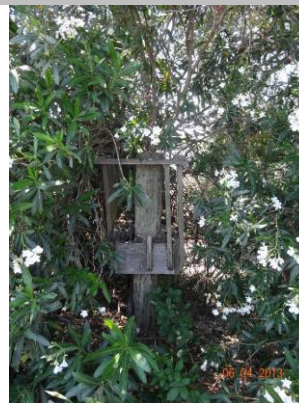
Photo 3 of 3 : UCIP_SP_2018_32530_58955.jpg

Comment Code						
Inspector Comment						
FS_ID:32530 DS_ID:21020 EP_NO: N/A Repair Type: Non-Urgent Crossing Status: Found UCIP Comments: Dense vegetation limits the inspector's visibility to identify signs of pipe failure (leaks) through the slope. Recommend removing vegetation along pipe alignment to conduct proper inspection of structure and appurtenances. If structure is no longer used--Need to contact owner to determine status. If crossing is no longer used owner will need to coordinate with CVFPB. FIELD_STRUCT_DESC: *ABANDONED* 16-inch irrigation discharge pipe of an unknown material through the levee, 6.5 feet below the crown. Siphon breaker and service pole on the landside (LS) shoulder. Electrical box at the LS toe. Pump on a pile structure in the channel. 3-inch steel sewer pipe sleeved through 16-inch pipe. Annular space grouted. ([Additional Reference(s): DWR Levee Log, 2005]. FS Date: 6/4/2013

Electrical box visible on landward toe.

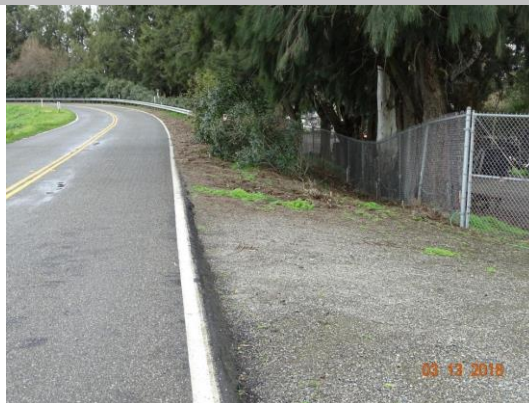
Photo 1 of 1 : SP_2018_RD0501_170_2_20180313_00048.jpg

LM Start	0.00	Rating **	M	Issue No.	2
LM End	0.09	Issue Type +	En	Location *	WS
Category	Earthen Levee			GPS Latitude/Longitude	
				Start	End
Item	Encroachments			38.184050 °	38.185178 °
				-121.657713 °	-121.658515 °
DWR ID	DWR_RD0501_02_s_2012_2				
Comment Code					
FE : Fence					
Inspector Comment					
This is the chainlink fence behind the guardrail.

Chainlink fence behind guardrail is not permitted.

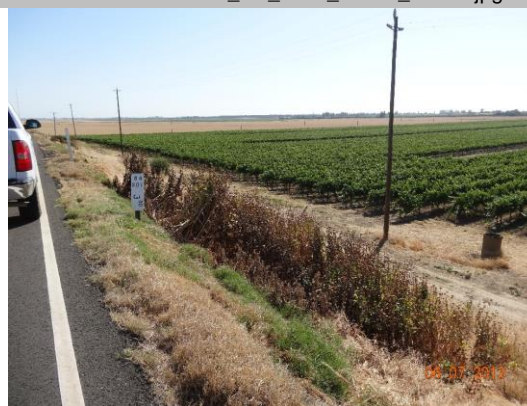
Photo 3 of 3 : UCIP_SP_2018_32531_58959.jpg

Comment Code						
Inspector Comment						
FS_ID:32531						
DS_ID:21035						
EP_NO: N/A						
Repair Type: Non-Urgent						
Crossing Status: Found						
UCIP Comments: Dense vegetation limits the inspector's visibility to identify signs of pipe failure (leaks) through the slope. Recommend removing vegetation along pipe alignment to conduct proper inspection of structure and appurtenances. Need to determine owner and status of crossing.						
FIELD_STRUCT_DESC: 10-inch irrigation discharge pipe of an unknown material sleeved through a 12-inch pipe of an unknown material through the levee, 5 feet below the crown. Pump on the waterside (WS). [Additional Reference(s): DWR Levee Log, 2005. USACE Sacramento O&M Manual 105, April 1959, (HLM 0.6)].						
FS Date: 6/7/2013

Overview of landward side.

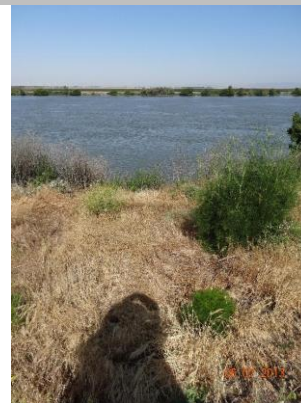
Photo 1 of 3 : UCIP_SP_2018_50018_58967.jpg

Comment Code					
Inspector Comment					
FS_ID:50018 DS_ID:21092 EP_NO: 3703 Repair Type: Urgent Crossing Status: Found UCIP Comments: 8/22/2016 Same as last inspection -- pipe is deteriorating and breaking apart (visible on WS). (DWR UCIP - omagana)6/07/2013 Deteriorated pipe with holes present at intake. Dense vegetation limits the inspector's visibility to identify signs of pipe failure (leaks) through the slope. Recommend removing vegetation along pipe alignment to conduct proper inspection of structure and appurtenances. If crossing is no longer used --owner will need coordinate with CVFPB to address crossing. Need to coordinate with DWR Inspector and CVFPB. (DWR UCIP - omagana) FIELD_STRUCT_DESC: *ABANDONED* 8-inch steel irrigation siphon pipe through the levee, 1.7 feet below the crown. Siphon breaker on the apex of the pipe on the landside (LS) shoulder. Pipe discharges into a concrete sump near the LS toe. Pipe is exposed along the LS slope. Second 8-inch pipe approximately 1 foot apart is visible on the LS. Pipe is also visible on the waterside (WS). (Retention of an existing 8-inch siphon pipe through the levee authorized under Permit No. 3703, 1961 - Enzo Guidi). [Additional Reference(s): DWR Levee Log, 2005]. FS Date: 8/22/2016

Overview of WS--20 foot berm present.

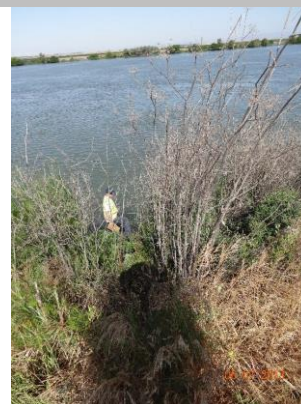
Photo 2 of 3 : UCIP_SP_2018_50018_58965.jpg

View of WS. Inspector is standing near exposed section of pipe at levee toe.

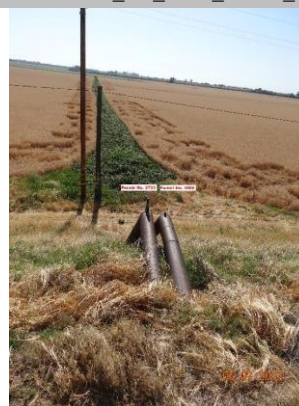
Photo 1 of 3 : UCIP_SP_2018_50019_58968.jpg

FS_ID:50019
DS_ID:21036
EP_NO: 1902
Repair Type: Urgent
Crossing Status: Found
UCIP Comments: 8/22/2016 Same as previous inspection. Pipe is deteriorating and open on WS. (DWR UCIP - omagana)6/07/2013 Reason for an Urgent Priority is due to adjacent crossing--adjacent crossing has holes present and is was installed in the 1960s. Our records show this pipe was installed before 1955. Dense vegetation limits the inspector's visibility to identify signs of pipe failure (leaks) through the slope. Recommend removing vegetation along pipe alignment to conduct proper inspection of structure and appurtenances. If crossing is no longer in use--Owner will need to coordinate with DWR Inspector and CVFPB. Need to determine condition of pipe--request maintenance records from owner once found--this crossing could be capped and grouted--NEED RECORDS. (DWR UCIP - omagana)
FIELD_STRUCT_DESC: *ABANDONED* 8-inch steel irrigation siphon pipe encased in a 10-inch, 14 gage corrugated metal pipe (CMP) through the levee, 1.7 feet below the crown. Siphon breaker on the apex of the pipe on the landside (LS) shoulder. Pipe discharges into a concrete sump near the LS toe. Pipe exposed along the LS slope. (Plans for replacing an existing pipe through the levee authorized under Permit No. 1902, 1954 - Enzo Guidi). [Additional Reference(s): DWR Levee Log, 2005. USACE Sacramento O&M Manual 105, April 1959, (HLM 0.9)].

8-inch pipes approximately 1 foot apart.

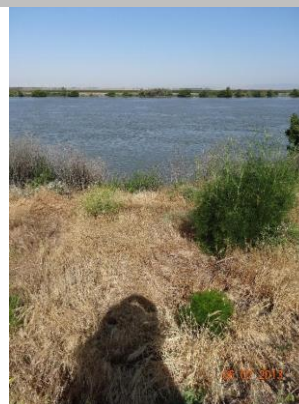
Photo 2 of 3 : UCIP_SP_2018_50019_58970.jpg

Overview of waterward side--20 foot berm present.

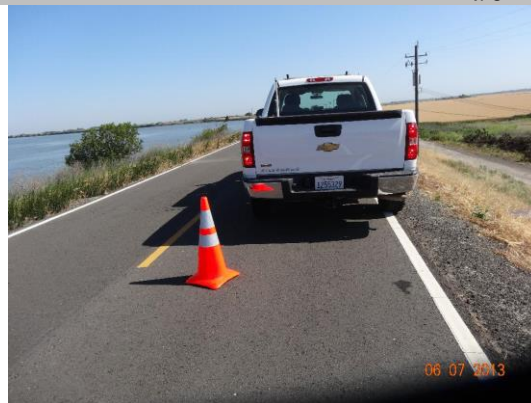
Photo 1 of 3 : UCIP_SP_2018_44865_58975.jpg

Comment Code					
Inspector Comment					
FS_ID:44865 DS_ID:21038 EP_NO: 2817 Repair Type: Non-Urgent Crossing Status: Found UCIP Comments: Dense vegetation limits the inspector's visibility to identify signs of pipe failure (leaks) through the slope. Recommend removing vegetation along pipe alignment to conduct proper inspection of structure and appurtenances. Scour hole located on waterward side. FIELD_STRUCT_DESC: 20-inch steel drainage discharge pipe sleeved through a 24-inch steel pipe through the levee, 9 feet below the crown. Flap gate on the waterside (WS) end. Cutoff wall around the pipe at each shoulder. Pipe exposed along both slopes. Rock revetment on the WS slope. Berm on the WS is over 20 feet. (Plans to install a drainage pipe through the levee authorized under Permit No. 2817, 1958 - Reclamation District No. 501 [RD0501])). [Additional Reference(s): DWR Levee Log, 2005]. FS Date: 6/7/2013

View of levee crown at crossings.

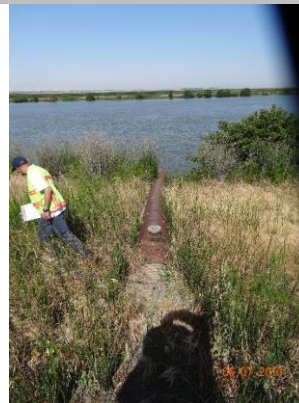
Photo 2 of 3 : UCIP_SP_2018_44865_58972.jpg

View of waterward side--pipe section exposed and siphon breaker. Over 20 feet berm on waterward side.

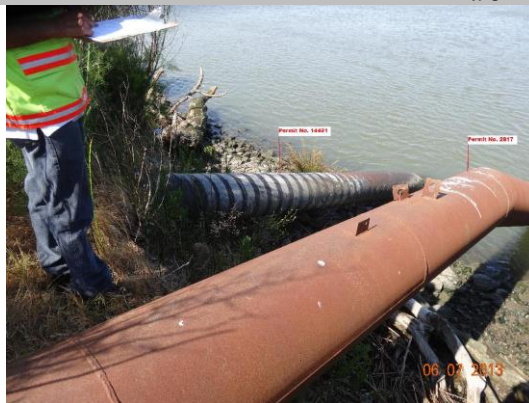
Photo 3 of 3 : UCIP_SP_2018_44865_58974.jpg

Comment Code						
Inspector Comment						
FS_ID:44865 DS_ID:21038 EP_NO: 2817 Repair Type: Non-Urgent Crossing Status: Found UCIP Comments: Dense vegetation limits the inspector's visibility to identify signs of pipe failure (leaks) through the slope. Recommend removing vegetation along pipe alignment to conduct proper inspection of structure and appurtenances. Scour hole located on waterward side. FIELD_STRUCT_DESC: 20-inch steel drainage discharge pipe sleeved through a 24-inch steel pipe through the levee, 9 feet below the crown. Flap gate on the waterside (WS) end. Cutoff wall around the pipe at each shoulder. Pipe exposed along both slopes. Rock revetment on the WS slope. Berm on the WS is over 20 feet. (Plans to install a drainage pipe through the levee authorized under Permit No. 2817, 1958 - Reclamation District No. 501 [RD0501]). [Additional Reference(s): DWR Levee Log, 2005]. FS Date: 6/7/2013

Waterward side--2-24 inch pipe inlets.

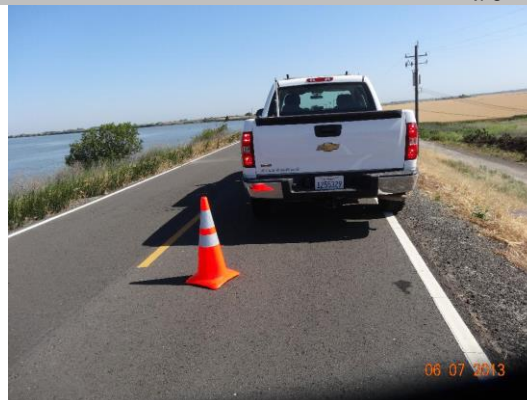
Photo 1 of 3 : UCIP_SP_2018_44866_58981.jpg

Comment Code					
Inspector Comment					
FS_ID:44866 DS_ID:21094 EP_NO: 14491 Repair Type: Non-Urgent Crossing Status: Found UCIP Comments: Dense vegetation limits the inspector's visibility to identify signs of pipe failure (leaks) through the slope. Recommend removing vegetation along pipe alignment to conduct proper inspection of structure and appurtenances. Scour hole present on waterward side. FIELD_STRUCT_DESC: 24-inch coated steel drainage discharge pipe through the levee, 4.5 feet below the crown. Cutoff wall around the pipe at the center of the levee. Siphon breaker on the apex of the pipe at the waterside (WS) shoulder. Pump on the landside (LS). (Plans to install a 24-inch water discharge pipe through the levee authorized under Permit No. 14491, 1986 - Reclamation District No. 501 [RD0501]). FS Date: 6/7/2013

View of downstream crown.

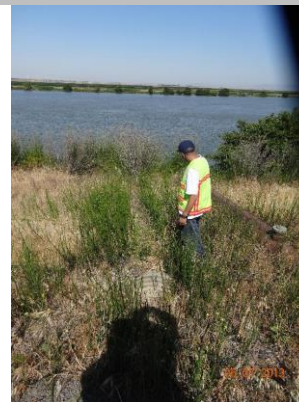
Photo 2 of 3 : UCIP_SP_2018_44866_58979.jpg

Two pipes on waterside.

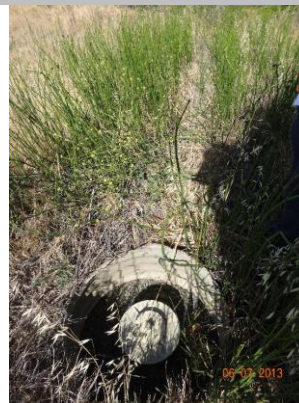
Photo 3 of 3 : UCIP_SP_2018_44866_58976.jpg

Comment Code						
Inspector Comment						
FS_ID:44866 DS_ID:21094 EP_NO: 14491 Repair Type: Non-Urgent Crossing Status: Found UCIP Comments: Dense vegetation limits the inspector's visibility to identify signs of pipe failure (leaks) through the slope. Recommend removing vegetation along pipe alignment to conduct proper inspection of structure and appurtenances. Scour hole present on waterward side. FIELD_STRUCT_DESC: 24-inch coated steel drainage discharge pipe through the levee, 4.5 feet below the crown. Cutoff wall around the pipe at the center of the levee. Siphon breaker on the apex of the pipe at the waterside (WS) shoulder. Pump on the landside (LS). (Plans to install a 24-inch water discharge pipe through the levee authorized under Permit No. 14491, 1986 - Reclamation District No. 501 [RD0501]). FS Date: 6/7/2013

Siphon breaker located at the waterward shoulder.

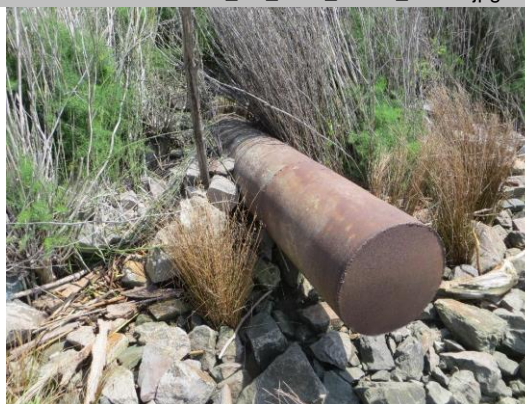
Photo 1 of 3 : UCIP_SP_2018_44753_73955.jpg

LM Start	1.25	Rating **	M	Issue No.	27
LM End	1.25	Issue Type +	Ma	Location *	
Category	Supplemental			GPS Latitude/Longitude	
				Start	End
Item	DWR UCIP LMA Responsibility			38.201143 °	38.201143 °
				-121.655169 °	-121.655169 °
DWR ID					
Comment Code					
Inspector Comment					
FS_ID:44753 DS_ID:21085 EP_NO: N/A Repair Type: Non-Urgent Crossing Status: Found UCIP Comments: Hole rusted through pipe on WS end. Pipe abandoned and should be done so properly. FIELD_STRUCT_DESC: *ABANDONED* 20-inch coated steel gravity drainage pipe through the levee, 15.5 feet below the crown. Pipe exposed along the waterside (WS) slope. Steel plate welded over end. [Additional Reference(s): USACE Sacramento O&M Manual 105, April 1959, (HLM 1.4)]. FS Date: 4/23/2015

20-inch pipe with welded steel plate over end on WS toe.

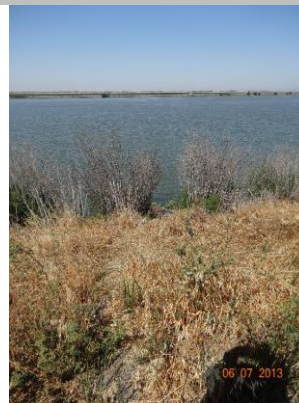
Photo 1 of 3 : UCIP_SP_2018_44867_58987.jpg

FS_ID:44867
DS_ID:21093
EP_NO: 13520
Repair Type: Non-Urgent
Crossing Status: Found
UCIP Comments: Dense vegetation limits the inspector's visibility to identify signs of pipe failure (leaks) through the slope. Recommend removing vegetation along pipe alignment to conduct proper inspection of structure and appurtenances. Owner needs to be informed about the vegetation clearance required for proper inspection.
FIELD_STRUCT_DESC: 18-inch coated steel irrigation siphon pipe through the levee, 3.4 feet below the crown. Steel cutoff wall around the pipe at the center of the levee. Siphon breaker on the apex of the pipe on the landside (LS) shoulder. Pipe extends from a sump off the LS toe. Pipe exposed along the waterside (WS) slope. Rock revetment on the WS slope. (Plans to remove two siphons and install one 18-inch steel siphon through the levee authorized under Permit No. 13520, 1982 - Lewis Nixon Company).

Overview of waterside. Dense vegetation.

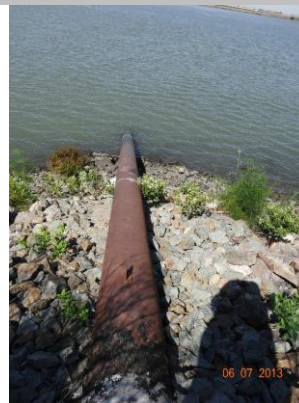
Photo 3 of 3 : UCIP_SP_2018_44867_58985.jpg

Comment Code						
Inspector Comment						
FS_ID:44867 DS_ID:21093 EP_NO: 13520 Repair Type: Non-Urgent Crossing Status: Found UCIP Comments: Dense vegetation limits the inspector's visibility to identify signs of pipe failure (leaks) through the slope. Recommend removing vegetation along pipe alignment to conduct proper inspection of structure and appurtenances. Owner needs to be informed about the vegetation clearance required for proper inspection. FIELD_STRUCT_DESC: 18-inch coated steel irrigation siphon pipe through the levee, 3.4 feet below the crown. Steel cutoff wall around the pipe at the center of the levee. Siphon breaker on the apex of the pipe on the landside (LS) shoulder. Pipe extends from a sump off the LS toe. Pipe exposed along the waterside (WS) slope. Rock revetment on the WS slope. (Plans to remove two siphons and install one 18-inch steel siphon through the levee authorized under Permit No. 13520, 1982 - Lewis Nixon Company). FS Date: 6/7/2013

Photo of pipe looking from berm edge to river edge.

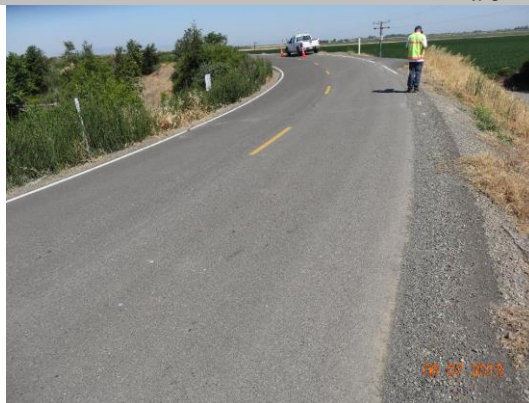
Photo 1 of 3 : UCIP_SP_2018_40489_33358.jpg

FS_ID:40489
DS_ID:21042
EP_NO: 15477
Repair Type: Non-Urgent
Crossing Status: Found
UCIP Comments: Stacey Boyd, LMA superintendent for RD0501, confirmed the removal and replacement of existing crossing under new permit no. 18811. New crossing will be a 30-inch diameter discharge pipe above the design flood plane. Construction will start soon. Update record once the project is completed. Dense vegetation on both waterside and landside. Recommend removing vegetation along pipe alignment to conduct proper inspection of structure and appurtenances. FIELD_STRUCT_DESC: 42-inch steel drainage discharge pipe through the levee, 6.5 feet below the crown. Siphon breaker on the waterside (WS) slope. Pump on the landside (LS). Pipe exposed along both slopes. (Plans to replace two pipes with two 36-inch discharge pipes through the levee authorized under Permit No. 15477, 1990 - Reclamation District No. 501 [RD0501]). Permit does not match this crossing. Recommend deletion of permit. [Additional Reference(s): DWR Levee Log, 2005. USACE Sacramento O&M Manual 105, April 1959, (HLM 2.0)].

Overview of crown, looking downstream.

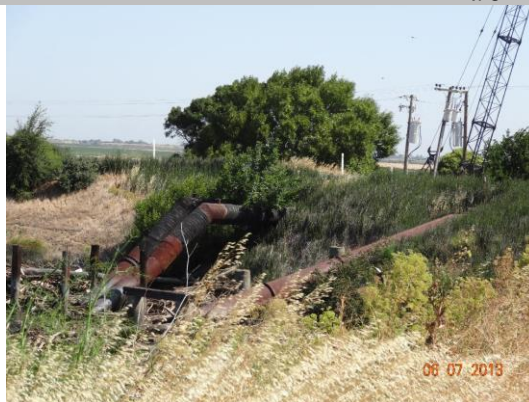
Photo 2 of 3 : UCIP_SP_2018_40489_33359.jpg

One 42-inch steel pile with siphon break on waterside slope.

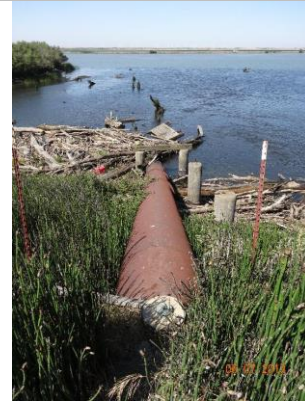
Photo 3 of 3 : UCIP_SP_2018_40489_33357.jpg

Comment Code						
Inspector Comment						
FS_ID:40489 DS_ID:21042 EP_NO: 15477 Repair Type: Non-Urgent Crossing Status: Found UCIP Comments: Stacey Boyd, LMA superintendent for RD0501, confirmed the removal and replacement of existing crossing under new permit no. 18811. New crossing will be a 30-inch diameter discharge pipe above the design flood plane. Construction will start soon. Update record once the project is completed. Dense vegetation on both waterside and landside. Recommend removing vegetation along pipe alignment to conduct proper inspection of structure and appurtenances. FIELD_STRUCT_DESC: 42-inch steel drainage discharge pipe through the levee, 6.5 feet below the crown. Siphon breaker on the waterside (WS) slope. Pump on the landside (LS). Pipe exposed along both slopes. (Plans to replace two pipes with two 36-inch discharge pipes through the levee authorized under Permit No. 15477, 1990 - Reclamation District No. 501 [RD0501]). Permit does not match this crossing. Recommend deletion of permit. [Additional Reference(s): DWR Levee Log, 2005. USACE Sacramento O&M Manual 105, April 1959, (HLM 2.0)]. FS Date: 6/7/2013

Siphon breaker on apex of steel pipe waterside.

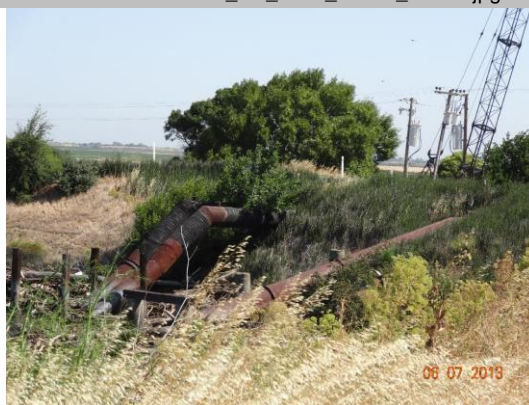
Photo 2 of 3 : UCIP_SP_2018_47050_33372.jpg

FS_ID:47050
DS_ID:21084
EP_NO: N/A
Repair Type: Non-Urgent
Crossing Status: Found
UCIP Comments: Dense vegetation limits the inspector's visibility to identify signs of pipe failure (leaks) through the slope. Recommend removing vegetation along pipe alignment to conduct proper inspection of structure and appurtenances.
FIELD_STRUCT_DESC: 2 of 2: 36-inch coated steel drainage discharge pipe through the levee, 7 feet below the crown. Siphon breaker on the waterside (WS) shoulder. Pump on the landside (LS). Pipe exposed along both slopes. Pipe supports at levee shoulders were cutoff walls from a preexisting pipe. Pipes are approximately 36 inches apart. (Plans to replace two pipes with two 36-inch discharge pipes through the levee authorized under Permit No. 15477, 1990 - Reclamation District No. 501 [RD0501]). [Additional Reference(s): DWR Levee Log, 2005].
FS Date: 6/7/2013

Overview of waterward side--3 crossings visible 1-42 inch pipe and 2-36 inch pipes.

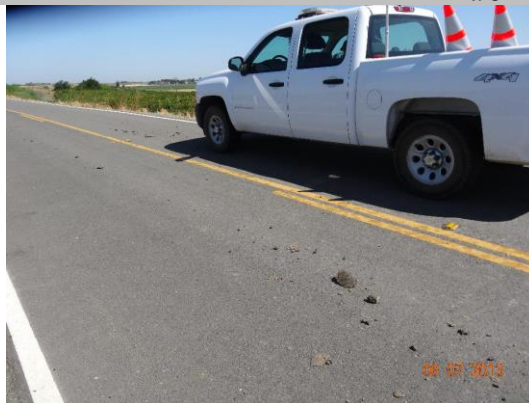
Photo 1 of 3 : UCIP_SP_2018_32537_58989.jpg

Comment Code					
Inspector Comment					
FS_ID:32537 DS_ID:21044 EP_NO: N/A Repair Type: Non-Urgent Crossing Status: Found UCIP Comments: Dense vegetation limits the inspector's visibility to identify signs of pipe failure (leaks) through the slope. Recommend removing vegetation along pipe alignment to conduct proper inspection of structure and appurtenances. FIELD_STRUCT_DESC: 14-inch coated steel irrigation siphon pipe through the levee, 6.2 feet below the crown. Siphon breaker on the waterside (WS) shoulder. (Plans to replace a section of an existing 14-inch pipe in the levee authorized under Permit No. 13937, 19 - Lewis Nixon Company). [Additional Reference(s): DWR Levee Log, 2005. USACE Sacramento O&M Manual 105, April 1959, (HLM 2.6)]. FS Date: 6/7/2013

View of levee crown--narrow road.

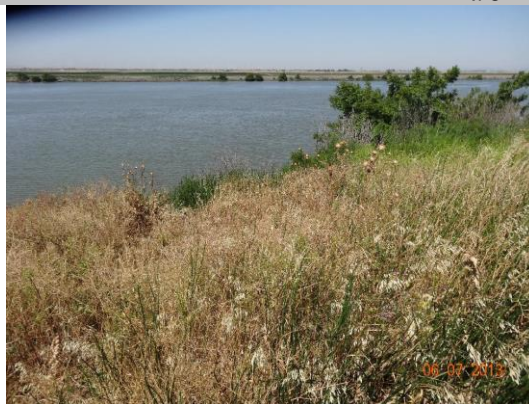
Photo 2 of 3 : UCIP_SP_2018_32537_58990.jpg

Photo taken just downstream of crossing looking at waterward side.

Comment Code					
Inspector Comment					
FS_ID:32537 DS_ID:21044 EP_NO: N/A Repair Type: Non-Urgent Crossing Status: Found UCIP Comments: Dense vegetation limits the inspector's visibility to identify signs of pipe failure (leaks) through the slope. Recommend removing vegetation along pipe alignment to conduct proper inspection of structure and appurtenances. FIELD_STRUCT_DESC: 14-inch coated steel irrigation siphon pipe through the levee, 6.2 feet below the crown. Siphon breaker on the waterside (WS) shoulder. (Plans to replace a section of an existing 14-inch pipe in the levee authorized under Permit No. 13937, 19 - Lewis Nixon Company). [Additional Reference(s): DWR Levee Log, 2005. USACE Sacramento O&M Manual 105, April 1959, (HLM 2.6)]. FS Date: 6/7/2013

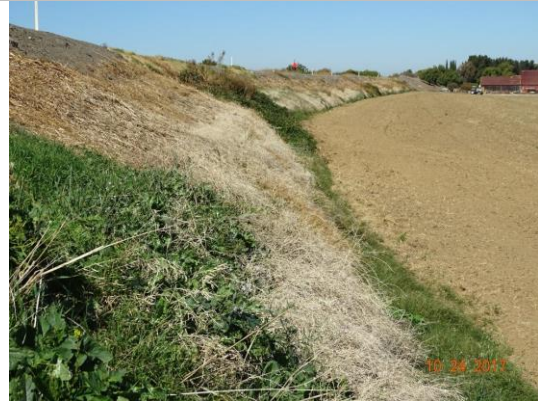
Photo 1 of 1 : SP_2018_RD0501_170_21_20180305_00002.jpg

LM Start	3.07	Rating **	M	Issue No.	21
LM End	3.33	Issue Type +	En	Location *	LS
Category	Earthen Levee			GPS Latitude/Longitude	
				Start	End
Item	Encroachments			38.221103 °	38.224732 °
				-121.671348 °	-121.672668 °
DWR ID	DWR_RD0501_02_f_2017_21				
Comment Code					
AT : Agricultural tilling					
Inspector Comment					
Aggricultural activity has cut into the landside levee toe resulting in a 4-foot tall, near vertical cut at the toe. This may destabilize the slope above. The toe should be reconstructed to the same slope angle as the levee slope above it.

Aggricultural activity has cut into the landside levee toe resulting in a 4-foot tall, near vertical cut at the toe. This may destabilize the slope above. The toe should be reconstructed to the same slope angle as the levee slope above it.

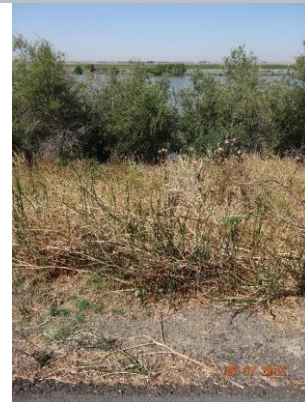
Photo 1 of 3 : UCIP_SP_2018_19657_33396.jpg

Comment Code					
Inspector Comment					
FS_ID:19657 DS_ID:21046 EP_NO: N/A Repair Type: Non-Urgent Crossing Status: Found UCIP Comments: Dense vegetation limits the inspector's visibility to identify signs of pipe failure (leaks) through the waterward slope. Recommend removing vegetation along pipe alignment to conduct proper inspection of structure and appurtenances. FIELD_STRUCT_DESC: 16-inch welded steel irrigation siphon pipe sleeved through a 20-inch coated steel pipe through the levee, 4.7 feet below the crown. Annular space grouted. Siphon breaker on the landside (LS) shoulder. Pipe exposed along both slopes. (Plans to place a new 16-inch welded steel pipe within the old 20-inch siphon authorized under Permit No. 2645, 1957 - Henry and Joseph Passaglia). [Additional Reference(s): DWR Levee Log, 2005. USACE Sacramento O&M Manual 105, April 1959, (HLM 3.3)]. FS Date: 8/22/2013

Dense vegetation along the crown hinge point and beginning section of waterward slope.

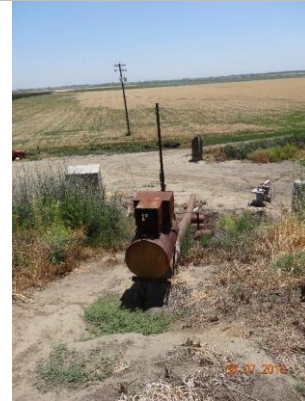
Photo 3 of 3 : UCIP_SP_2018_44873_33404.jpg

Comment Code						
Inspector Comment						
FS_ID:44873 DS_ID:21065 EP_NO: N/A Repair Type: Non-Urgent Crossing Status: Found UCIP Comments: Pump operating during inspection. Need to determine owner. Dense vegetation limits the inspector's visibility to identify signs of pipe failure (leaks) through the waterward slope. Recommend removing vegetation along pipe alignment to conduct proper inspection of structure and appurtenances. FIELD_STRUCT_DESC: 14-inch steel irrigation discharge pipe through the levee, 6.3 feet below the crown. Siphon breaker on the landside (LS) slope. Pipe exposed on both slopes. [Additional Reference(s): DWR Levee Log, 2005. USACE Sacramento O&M Manual 105, April 1959, (HLM 0.7), 16-inch pipe referenced]. FS Date: 6/7/2013

Overview of landward side--pump sytem, pipe, and standpipe.
